Chairside

Functional and Esthetic Rehabilitation Using a Captek™ Bridge and Crowns Opposing Laminate Porcelain Veneers

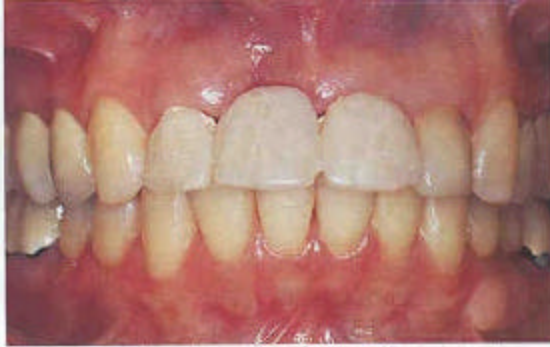
Figure 1—Facial view in centric occlusion before treatment.

In the following clinical case, all the anterior teeth were restored to achieve the patient's goal of esthetic rehabilitation. However, we accomplished another important service: We established protrusive and lateral anterior guidance with contact on the restorative material. The patient mature woman, appeared with a temporary acrylic bridge already in place from her maxillary right central to her left lateral incisor. Figure 1 shows the facial view with her teeth closed in centric occlusion. She exhibited Class 1 occlusion with acceptable overbite and overjet. However, the current temporary bridge exhibited a slight negative smile line curving upward at the central position. We planned to lengthen the incisal edges in her final restoration to create a more pleasing smile line. The posterior plane of occlusion was good and the vertical dimension of occlusion was unaltered. The occlusal view in Figure 2 shows an acceptable arch form with previous porcelain-fused-to-metal crowns on her first and second premolars. The right central incisor had been extracted and the tissue here was still in a healing stage. The mandibular incisors exhibited a natural wear pattern and, in fact, had worn through the enamel to the underlying dentin on the incisal edges (Figure 3). The patient's desire was for lighter, more youthful-looking teeth.

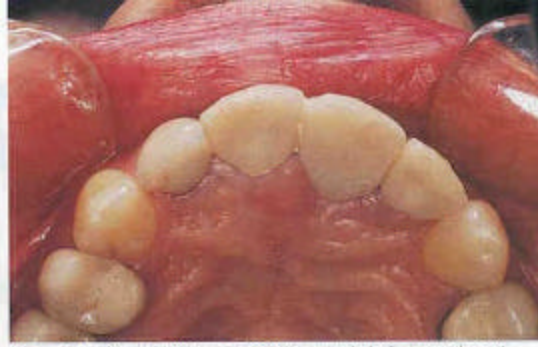
Figure 2—Occlusal view of maxillary arch before treatment.

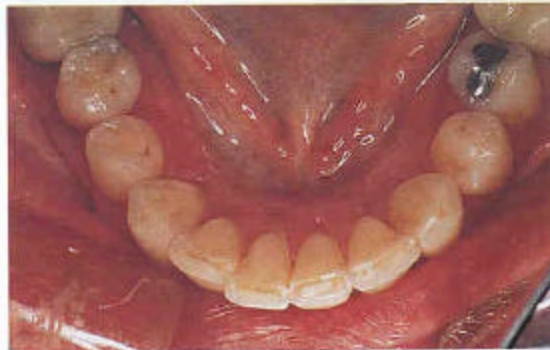
Figure 3—Occlusal view of mandibular arch before treatment.

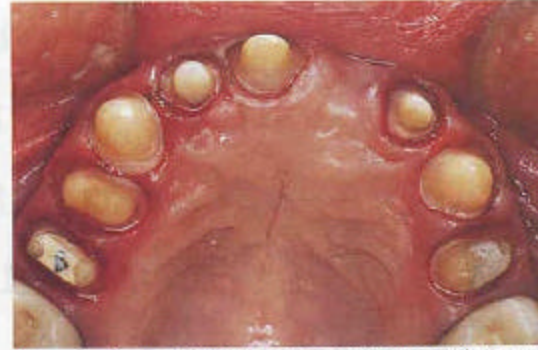
Figure 4—Occlusal view of maxillary teeth prepared for Captek restorations.

The tissue at the extraction site where tooth No. 8 used to be had less-than-ideal contour, so the patient was referred to a periodontist for grafting. On healing, the patient's 10 maxillary most anterior teeth (second premolar to second premolar) were prepared for full-crown restorations (Figure 4). Captex™ was the material chosen for the maxillary crowns and bridge because of its excellent potential for esthetics and its superior strength characteristics. The metal foundation is strong enough for bridge work even though it is very thin. The warm gold color of the thin metal copings gives the overlying porcelain a true-to-life appearance. Minimal tooth preparation (1.0 mm axial and 1.5 mm incisal or occlusal reduction) is necessary to make room for this material. A chamfer margin at the level of the tissue height is all that is needed for esthetics because the gold coping is thin enough to be covered by porcelain without causing the margin to be thick and unnaturally overcontoured. Therefore, no subgingival preparation is required and the tissue health is maximized.

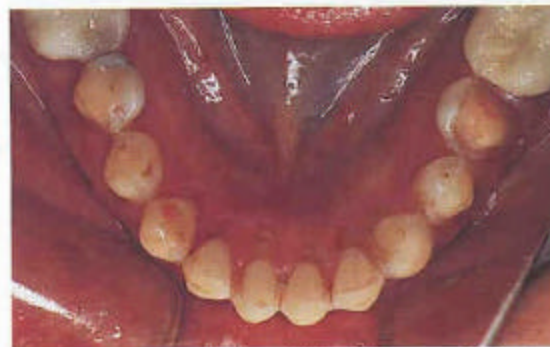
Figure 5—Occlusal view of mandibular teeth prepared for laminate veneers.

The mandibular incisors and premolars were conservatively prepared for porcelain laminates (Figure 5) with only 0.5 mm of facial reduction and 1.0 mm of incisal and occlusal reduction. The objective of these restorations was to create a more pleasing esthetic appearance while providing a functional surface in porcelain surfaces. Figure 6 illustrates the maxillary and mandibular prepared teeth from the facial view.

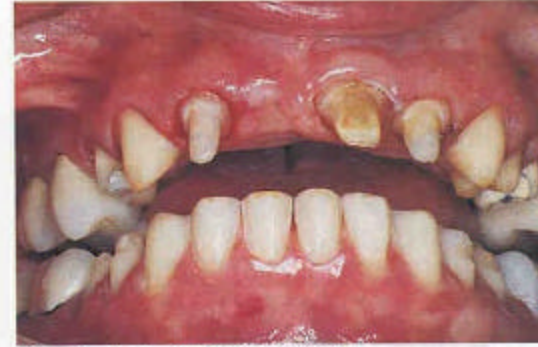
Figure 6—Facial view of prepared teeth.

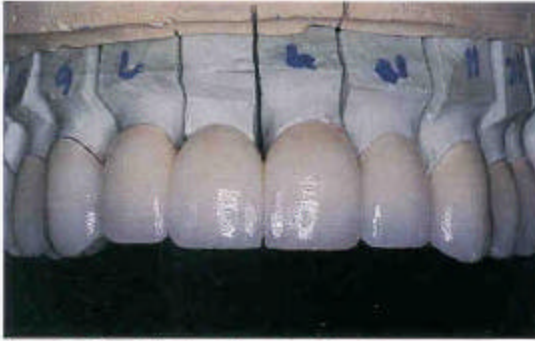
Figure 7—Captex™ restorations on working cast.

Figure 7 shows the final Captek™ restorations on the working model. Figure 8 shows all the Captek™ restorations photographed on a mirror surface. Note the warm gold color of the coping material and thin margins covered in porcelain. Figure 9 shows a close-up of the Captek™ three-unit bridge replacing tooth No. 9. Note the vitality, the gingivoincisor blend of colors, and the natural incisal translucency created in the dental laboratory. Figure 10 illustrates very thin margins covered with porcelain for esthetics. We can also see the formation of natural proximal embrasures and the ovate pontic shape.

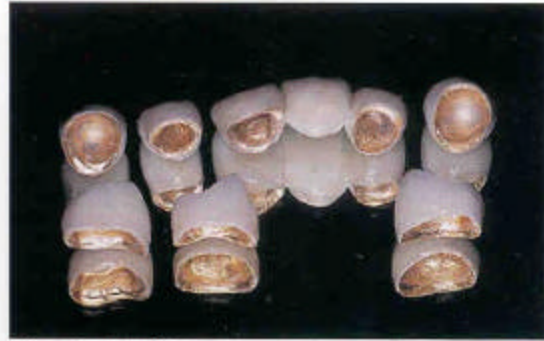
Figure 8—Captex™ restorations on mirror surface.

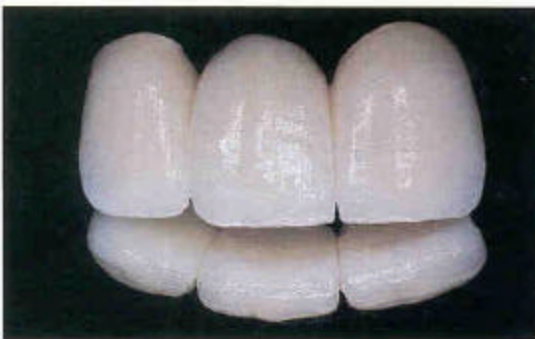
Figure 9—Captex™ three-unit bridge—facial view.

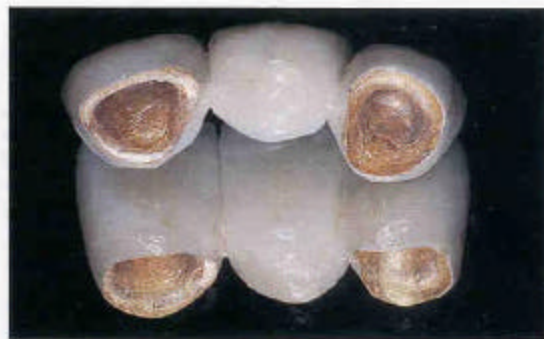
Figure 10—Captex™ three-unit bridge—internal surfaces.

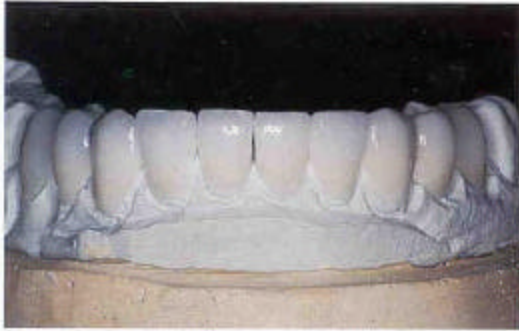
Figure 11—Porcelain laminate veneers on working model.

In Figure 11, the porcelain laminate veneers (Optec™ hsp_f) can be seen on the working model. Figure 12 shows the external surfaces with beautiful gingival and incisal tones and translucent incisal edges. The internal etched surfaces of the porcelain laminates are seen in Figure 13.

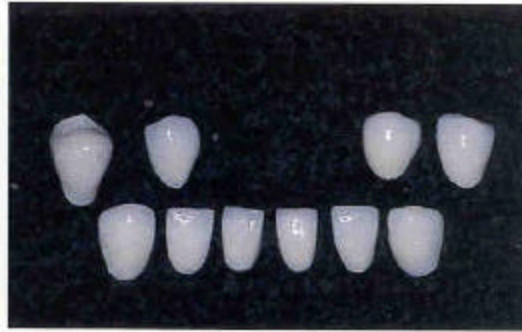
Figure 12—Porcelain laminate veneers—facial surfaces.

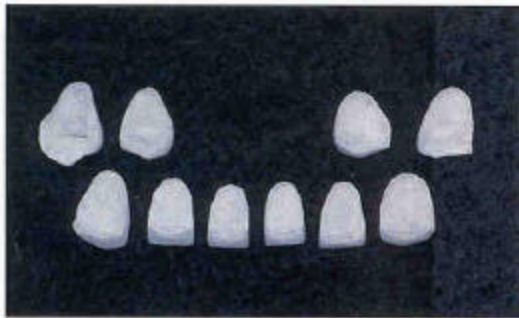
Figure 13—Porcelain laminate veneers—internal etched surfaces.

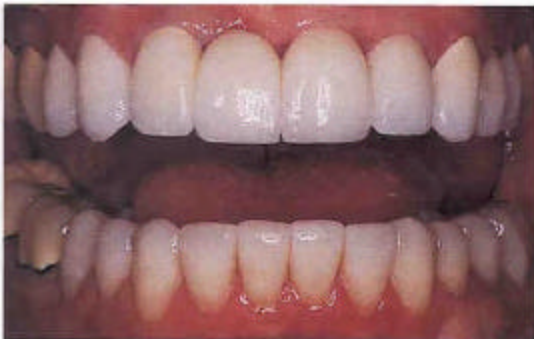
Figure 14—Final result—facial view.

Figure 14 shows the final result from the facial view. Note the excellent esthetics and tissue health. Note also that we accomplished our goal of eliminating the reverse curve in the anterior smile line. Occlusal views of the maxillary and mandibular arches can be seen in Figures 15 and 16, respectively. Centric occlusion is illustrated in Figure 17. Protrusive guidance with posterior disocclusion is seen in Figure 18; right and left lateral canine guidance with posterior disocclusion are illustrated in Figure 19 and 20. We accomplished esthetic and functional rehabilitation using the modalities of Captek™ crowns and bridges on the maxillary arch and bonded laminate veneers on the mandibular arch. The patient's attractive new smile can be seen in the full-face view in Figure 21.

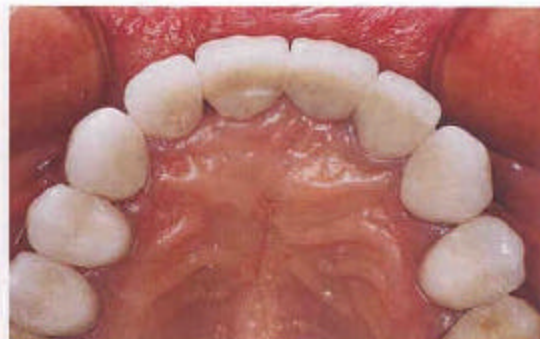
Figure 15—Captek™ restorations—occlusal view.

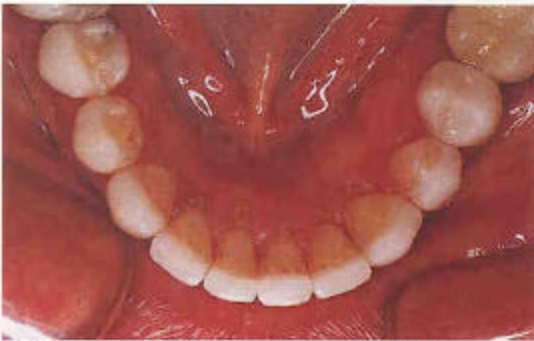
Figure 16—Porcelain laminate veneers—occlusal view.

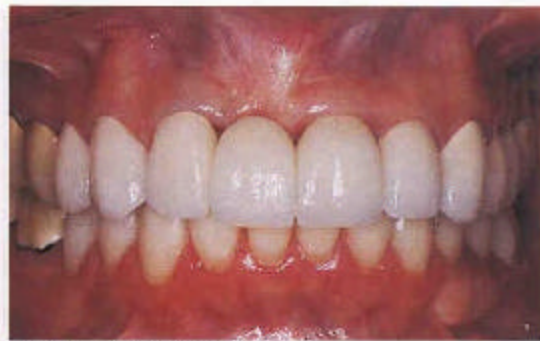
Figure 17—Centric occlusion.

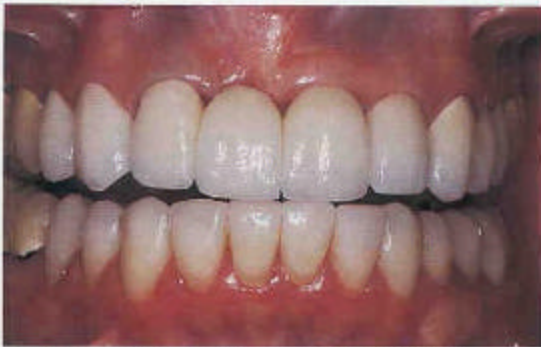
Figure 18—Pretrusive guidance—posterior disocclusion.

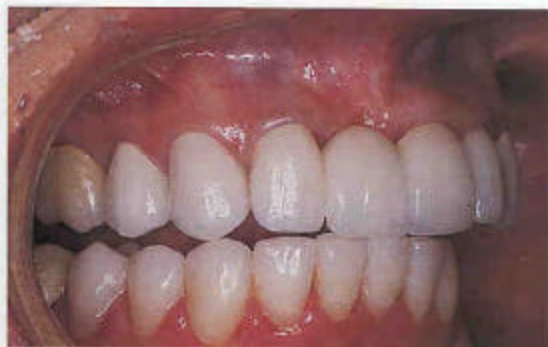
Figure 19—Right canine guidance—posterior disocclusion.

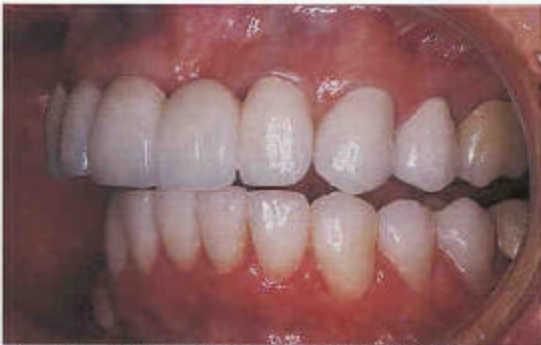
Figure 20—Left canine guidance—posterior disocclusion.
